Hawaiian Electric Company, Inc.'s
Report on the October 15-16, 2006 Outage

December 28, 2006

Investigation of 2006 Oahu Island-Wide Power Outage
PUC Docket Number 2006-0431

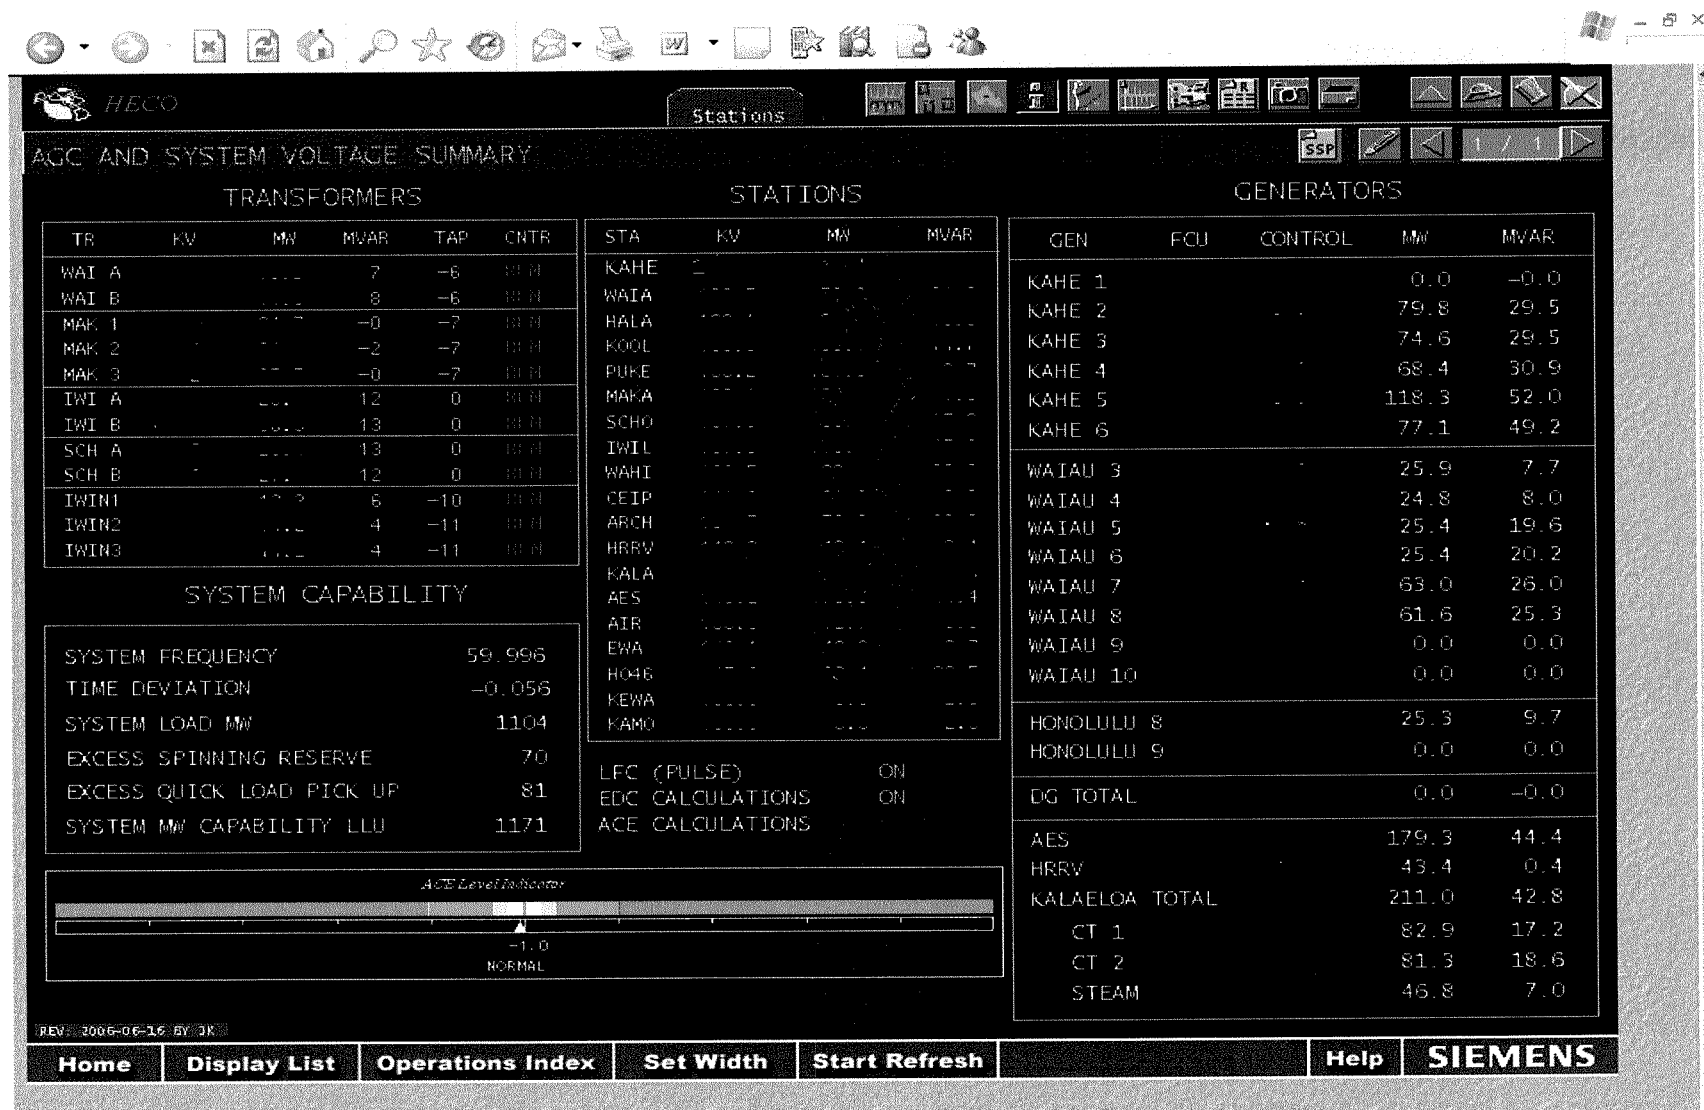
We have developed the sequence of events from just before the earthquake to the outage using information from the EMS alarm log and HECO's employees present that day. This sequence of events coincides with the information displayed in the following figures. Figure 1 shows an example of the information displayed on the EMS AGC screens utilized by the dispatch personnel as the basis for their decisions. Figure 2 show the system generation/load and frequency with the timing of significant events on the HECO system from the time of the earthquake until K1 tripped. Figure 3 shows the megawatt output of the separate generating units and the system

Figure 1: Example EMS AGC Screen (Station specific information was redacted for Homeland Security purposes)
